**DRAFT EXPANDED SITE INSPECTION REPORT  
FOR  
CRANSTON SANITARY LANDFILL  
CRANSTON, RHODE ISLAND**

**CERCLIS No. RID084812577**

**PREPARED BY:  
RHODE ISLAND DEPARTMENT OF ENVIRONMENTAL MANAGEMENT  
DIVISION OF SITE REMEDIATION**

**April 18, 1995**

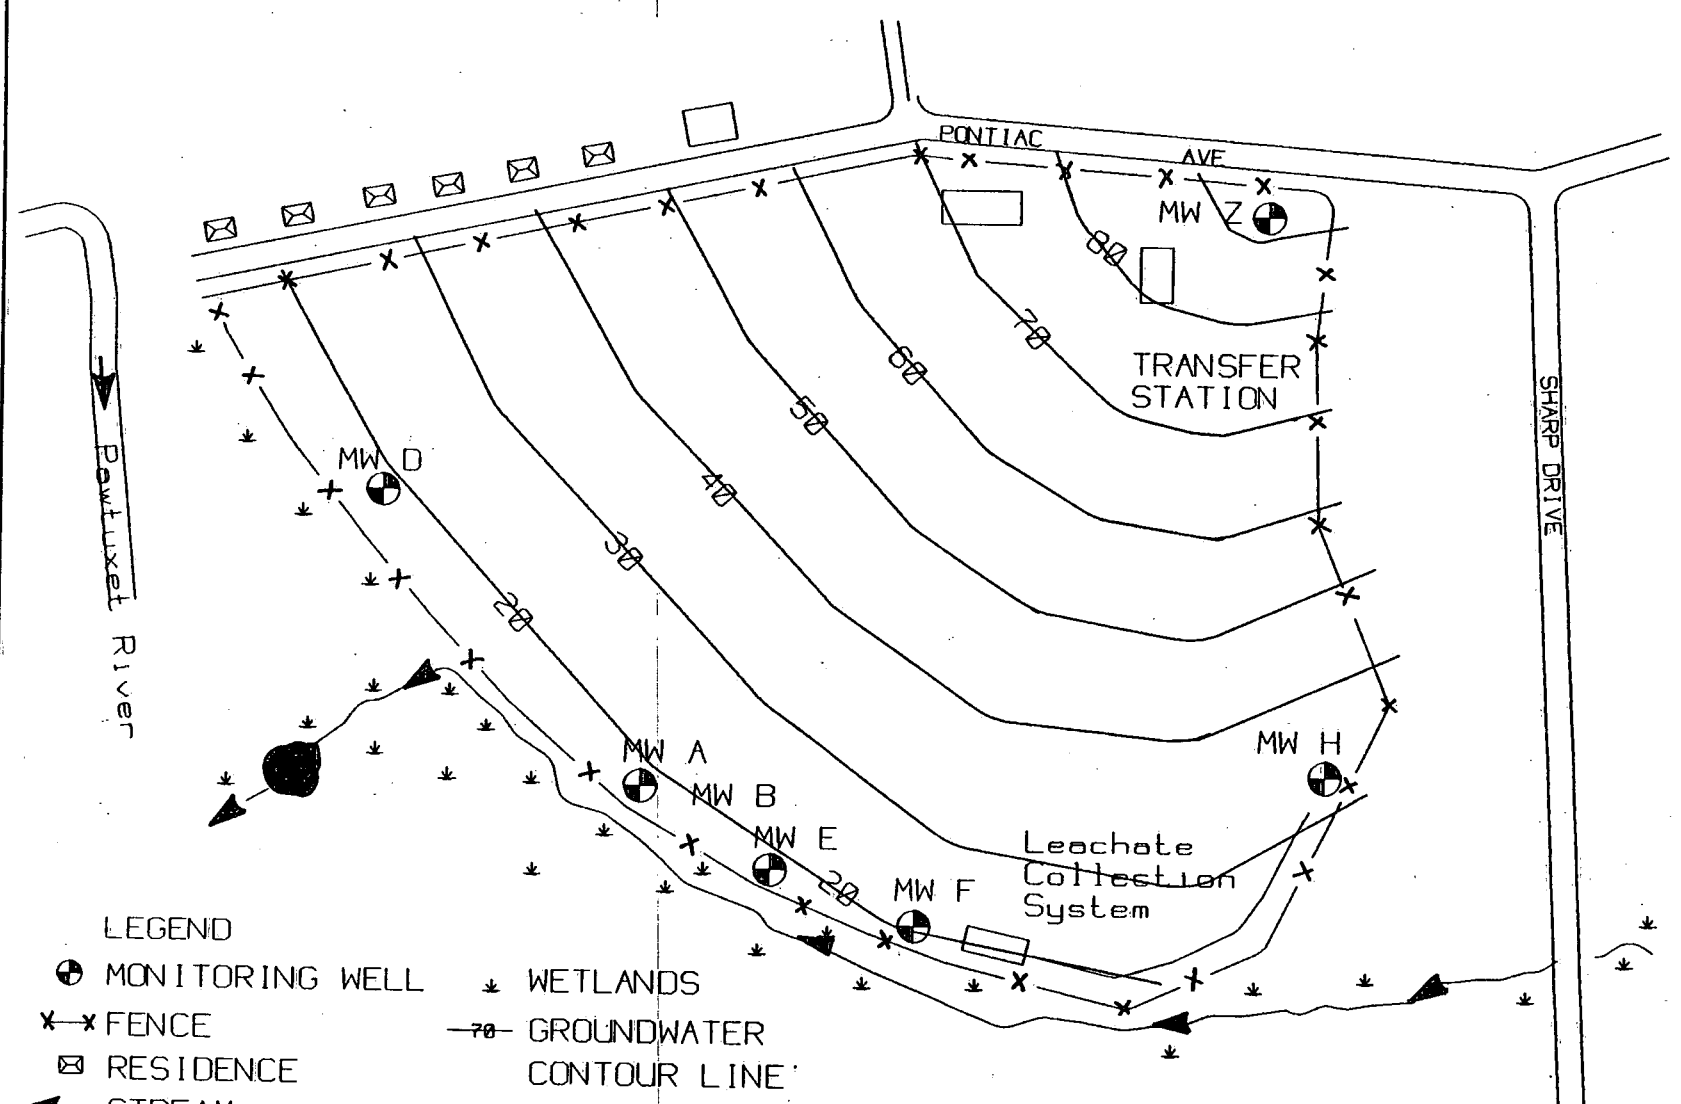
A groundwater contour map of the site was developed by Pare Engineering for CSL. The map, dated 16 March 1990, indicates that groundwater in the area flows in an easterly and/or southeasterly direction toward the unnamed stream and associated wetlands located adjacent to the site. This adjacent, unnamed stream was sampled by RIDEM/DSR in December, 1993 as part of the ESI. Figure 3 is a modified copy of the groundwater contour map.

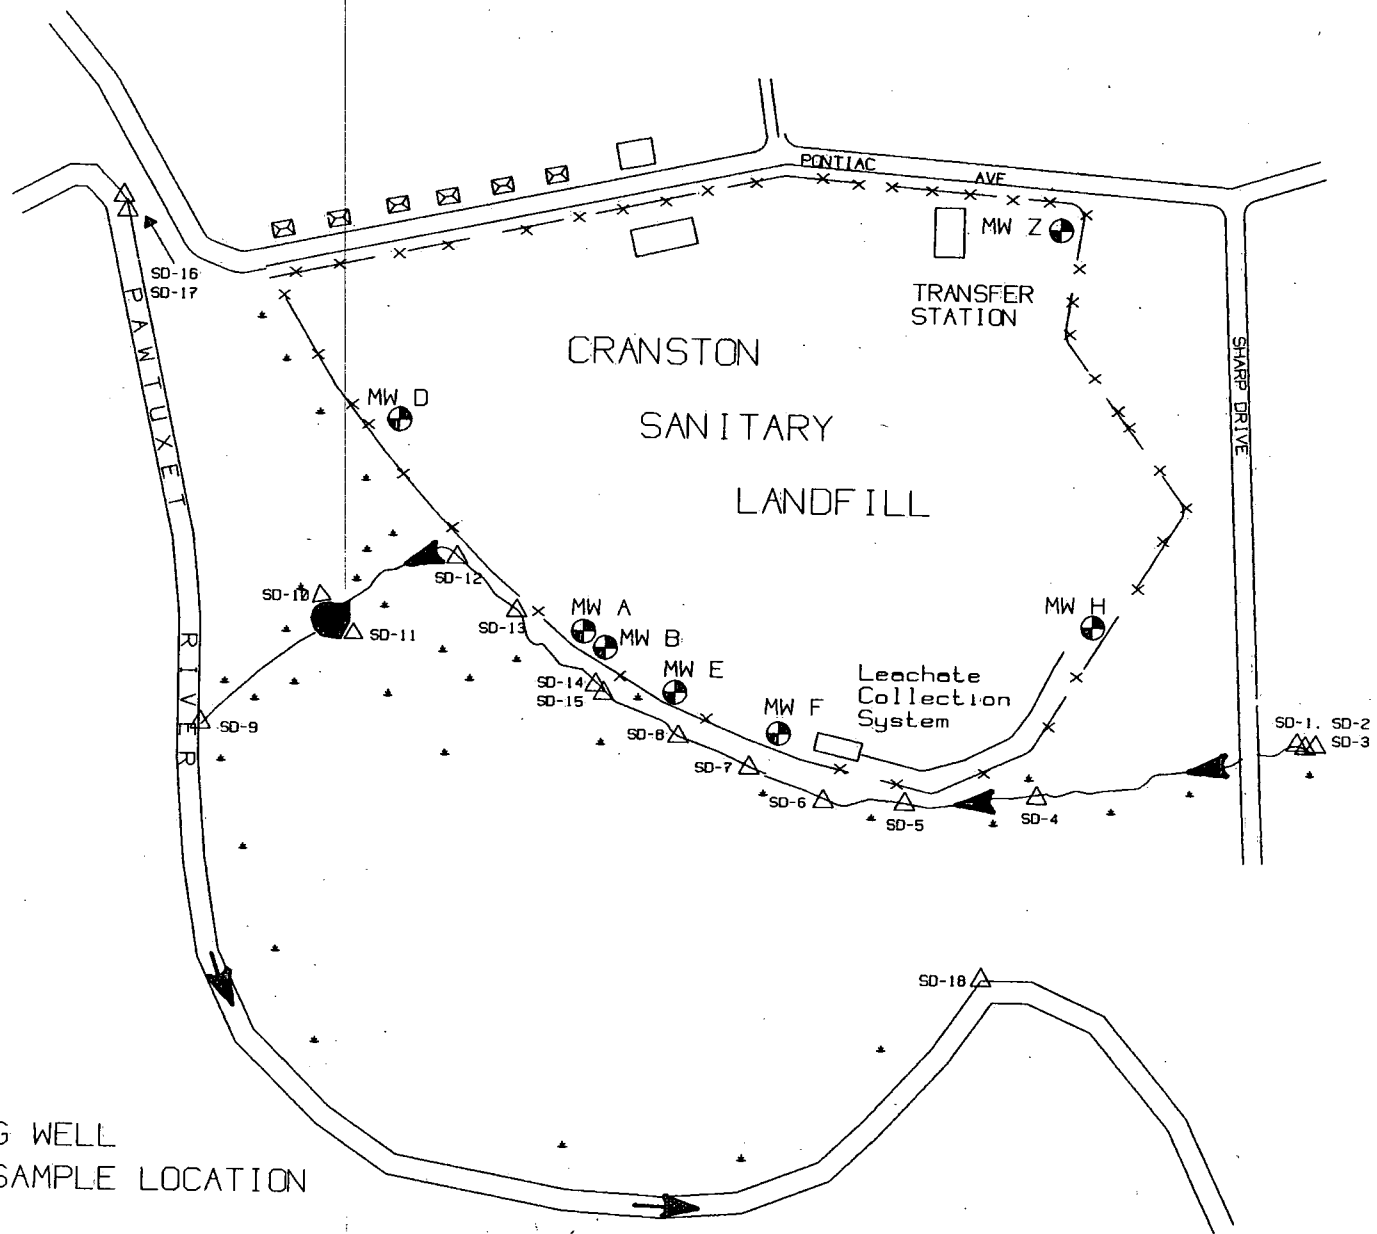
Figure 6 is a sketch of the site showing the relative locations of the monitoring wells and the 1993 sediment samples.
